*Geomorphic and Riparian
Vegetation Assessment
of the
Proposed Napa River Flood Control Project
near the
City of St. Helena, Napa County, California*

Mitchell Swanson, Swanson Hydrology & Geomorphology

October 31, 2002

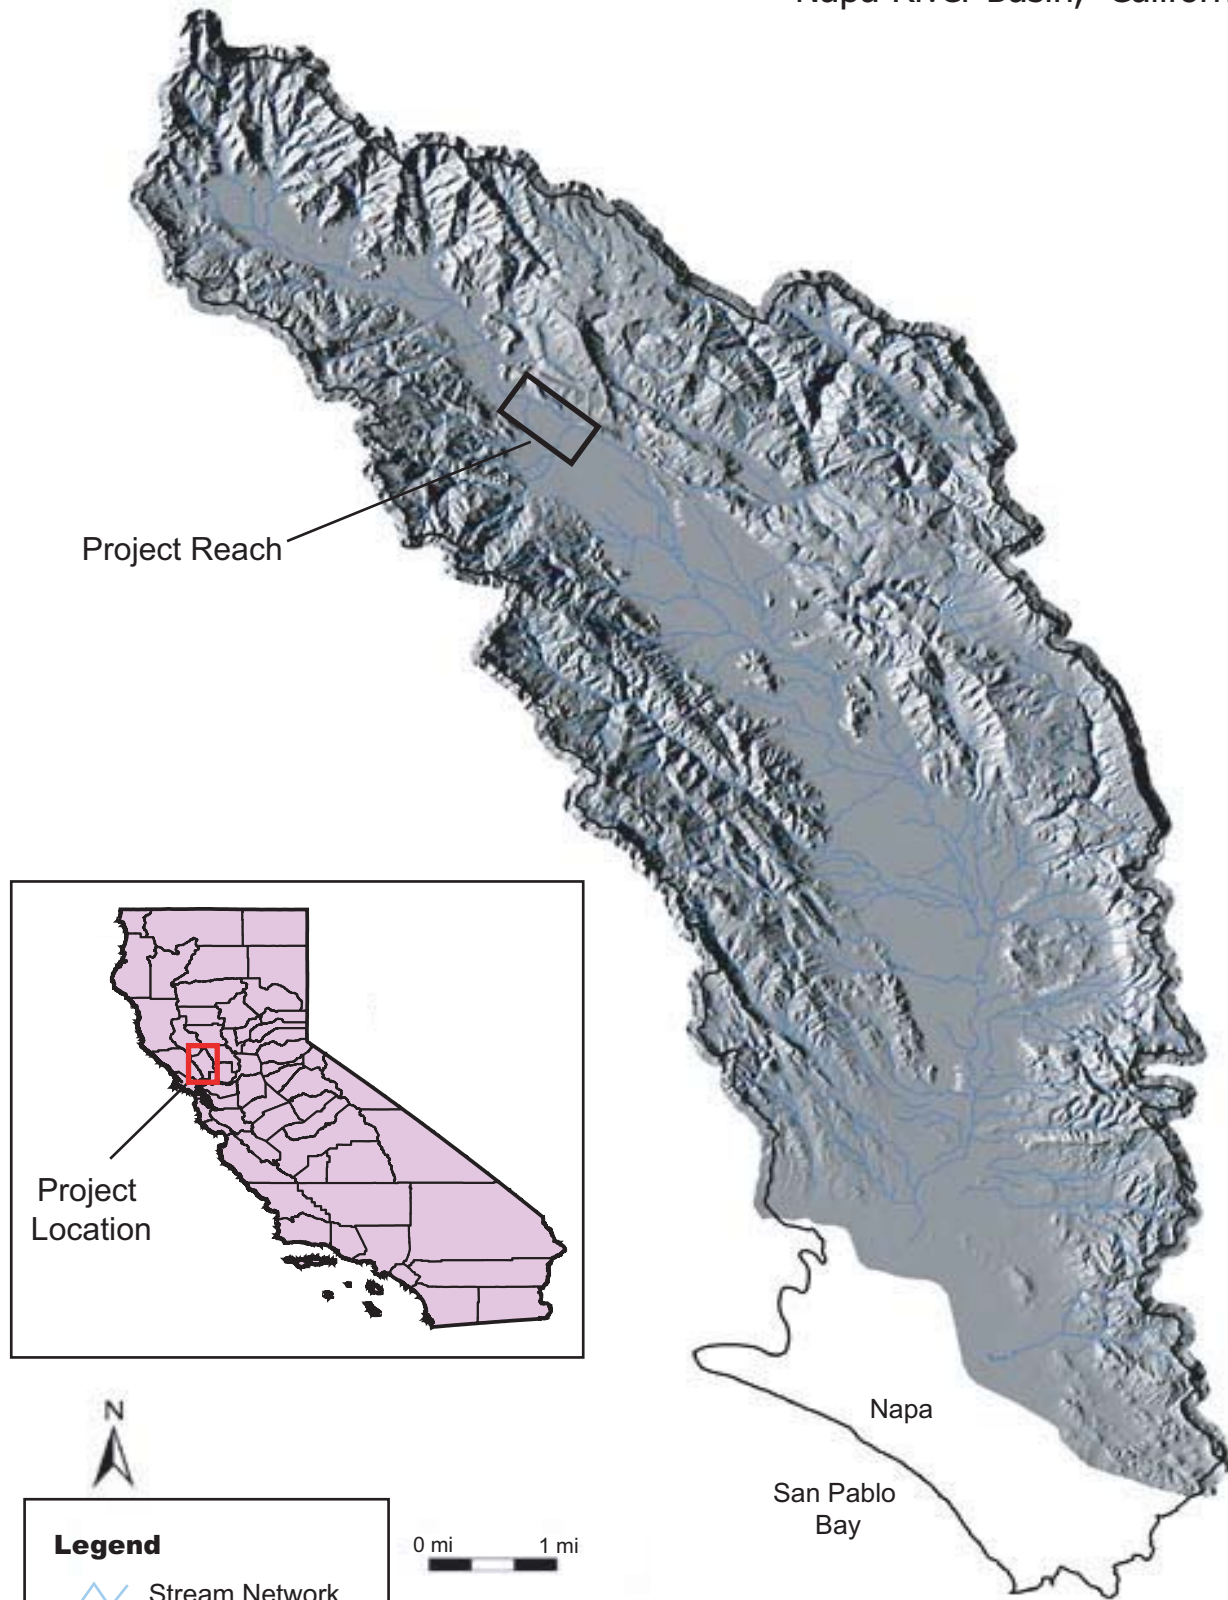
Figure 1: Napa River Basin watershed map.

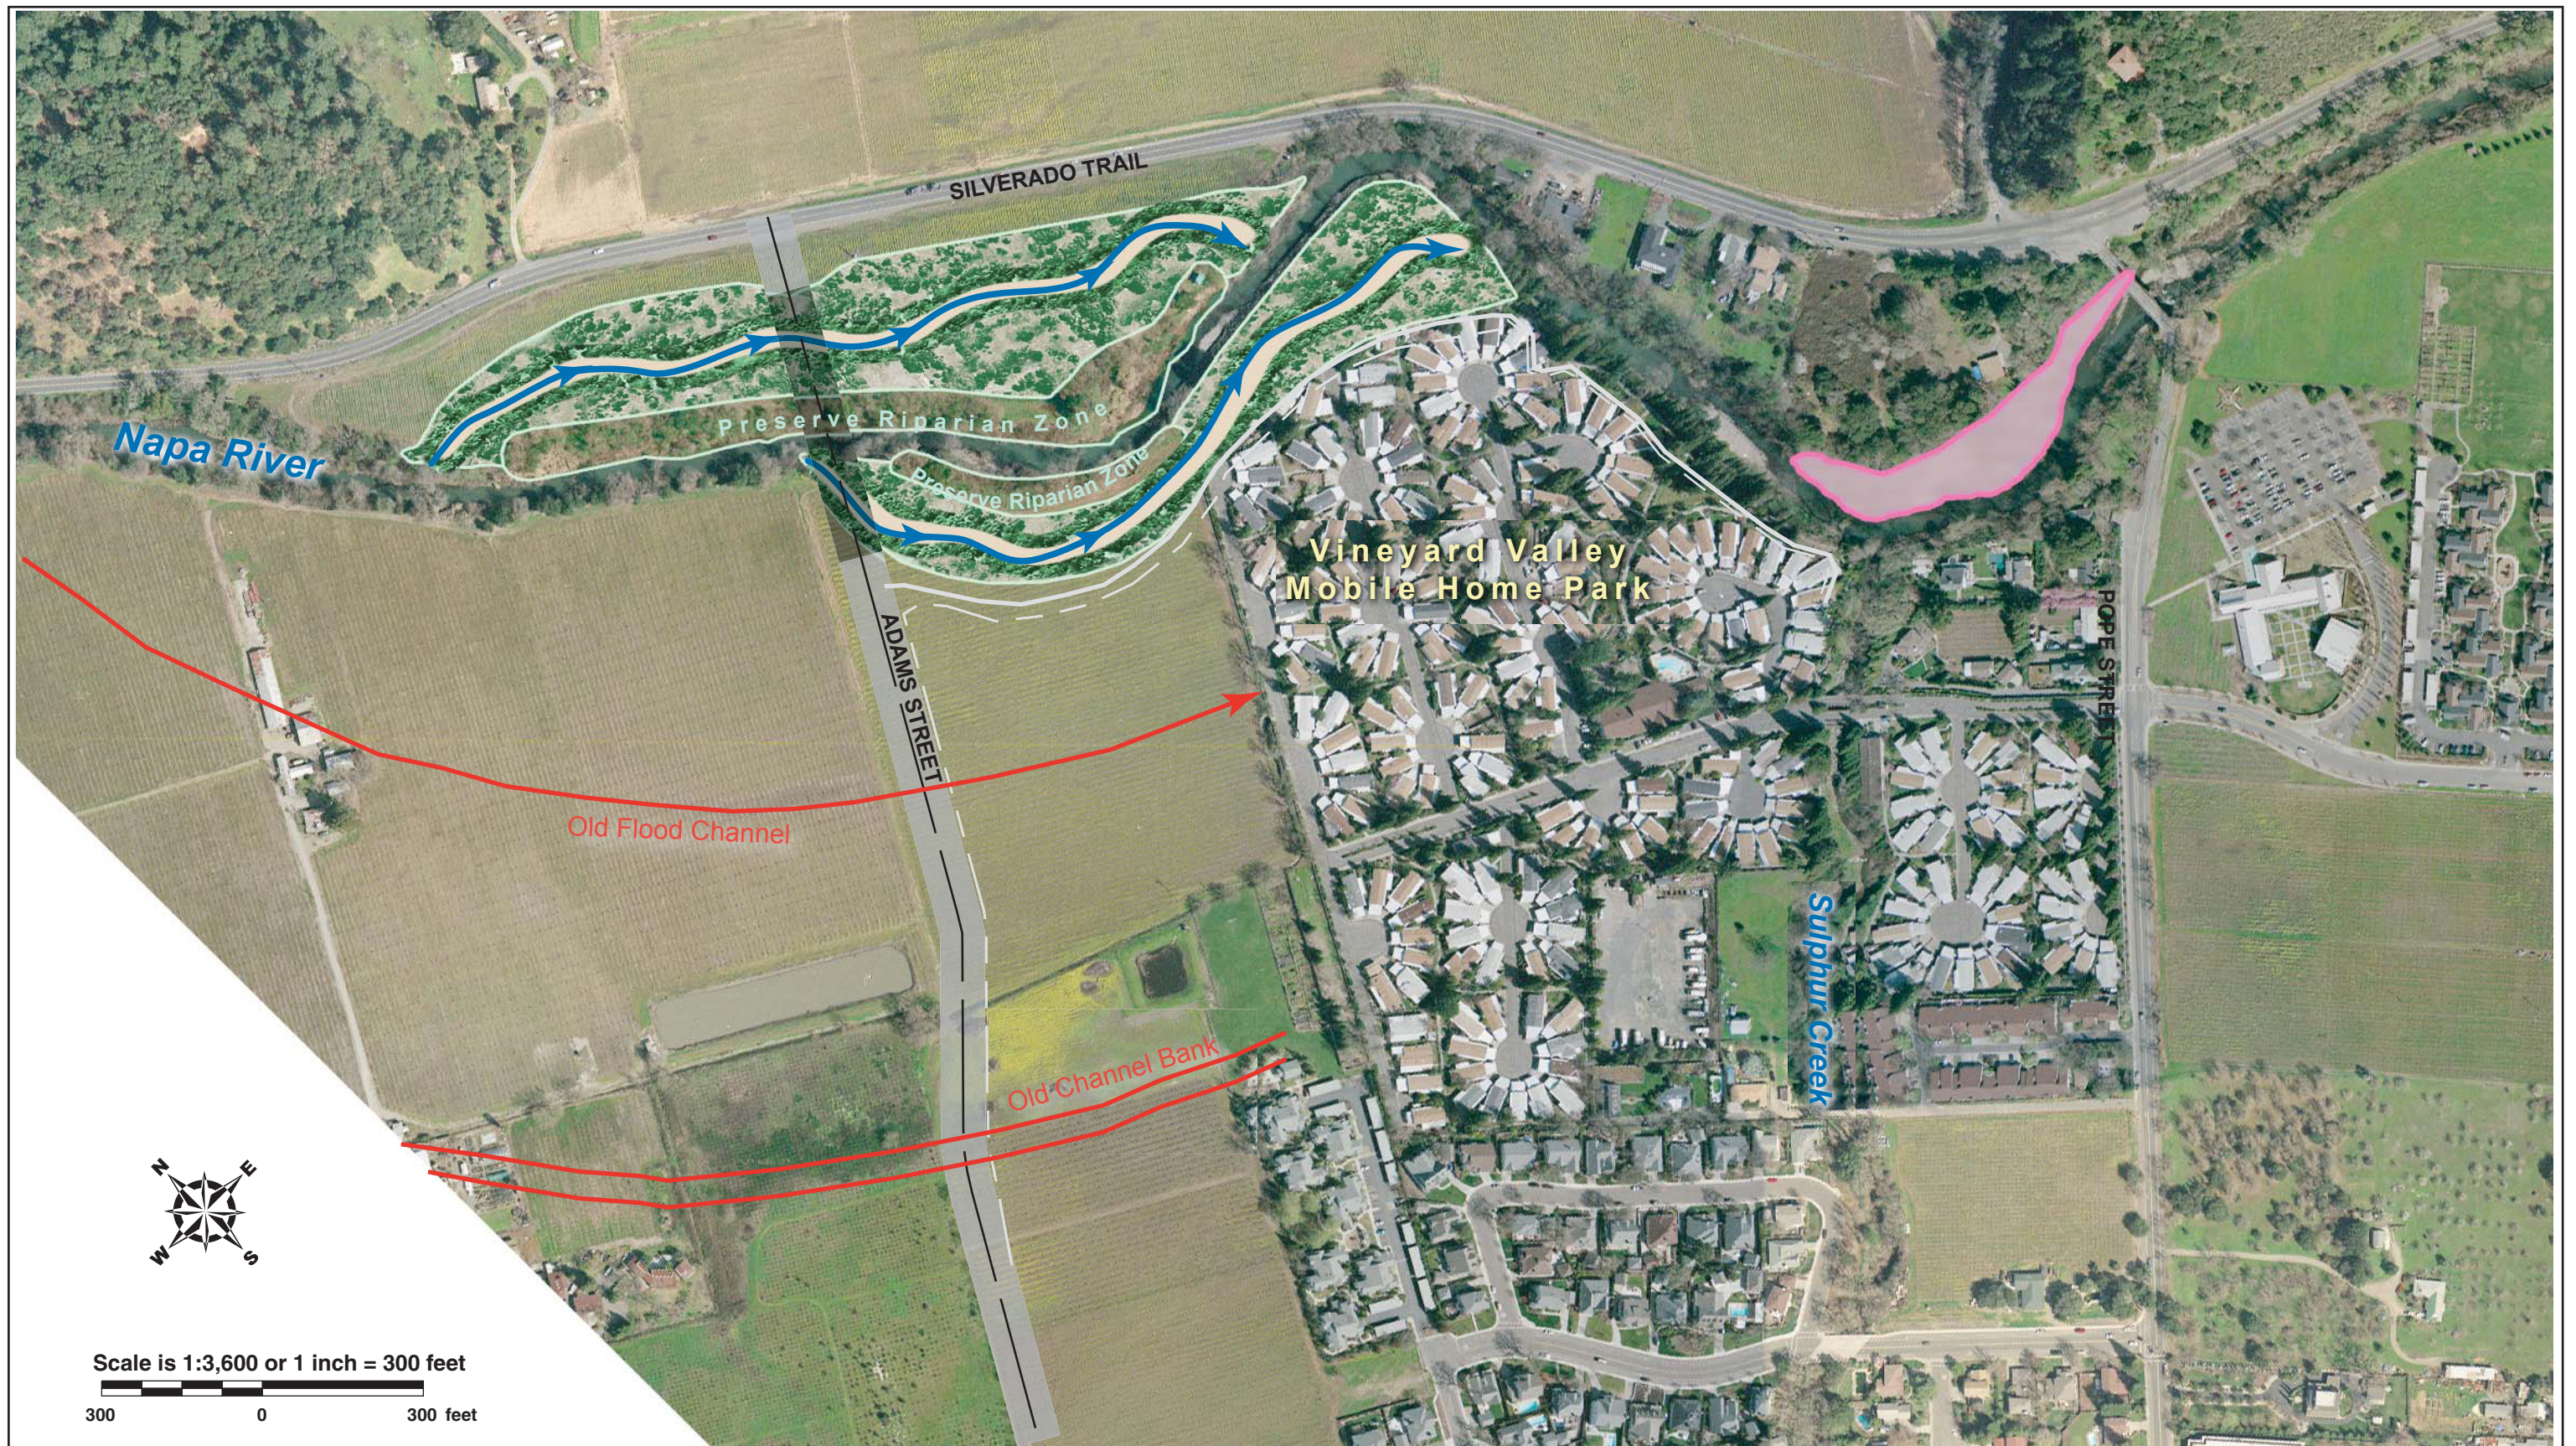
Figure 3: Napa River near St. Helena flood control project map

Figure 3 shows the proposed “enhanced minimum plan” alternative in plan view. This geomorphic and vegetation assessment first considers the enhancement minimum plan (EMP) in detail and then examines the differences in impacts and benefits to the “minimum plan”. These two alternatives and the existing conditions “no-action” plan are presently under environmental review.

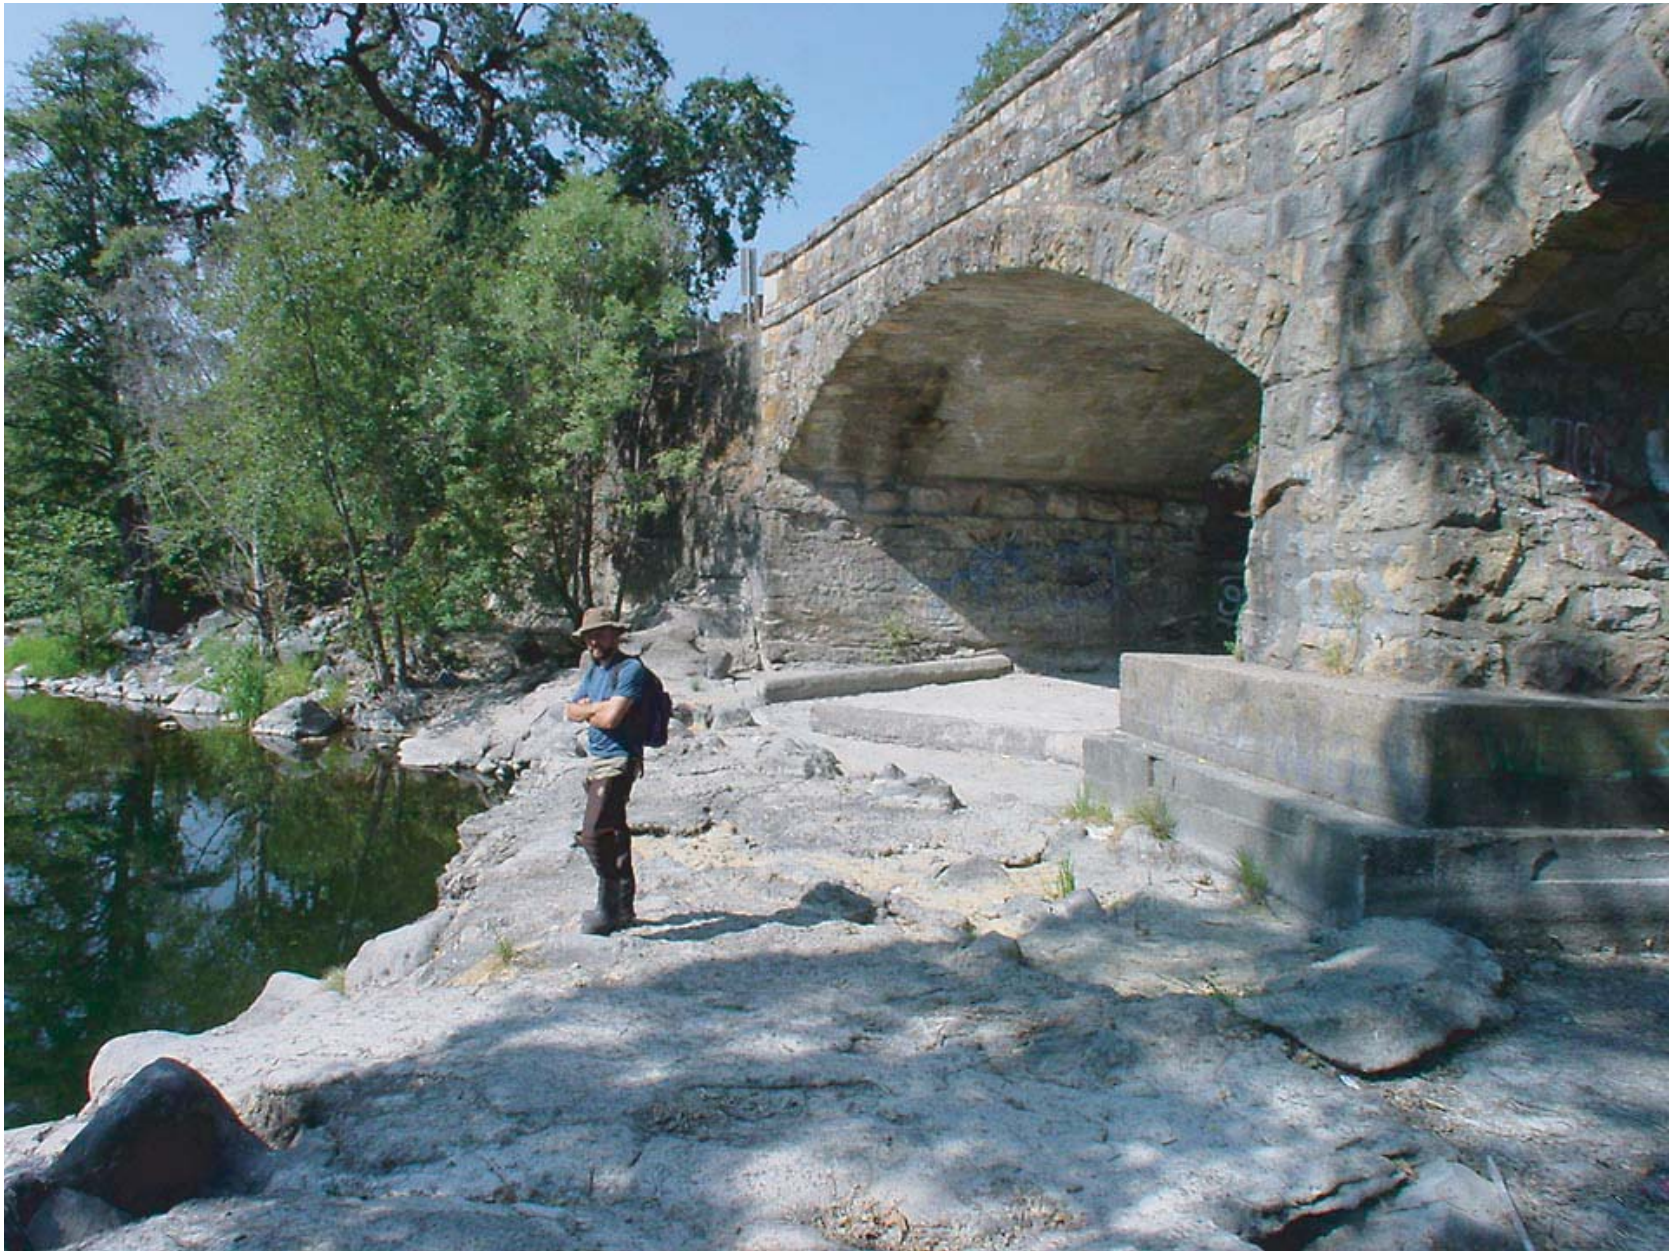
Figure 4: Napa River at downstream face of Zinfandel Bridge several miles downstream of project site. The bridge has been repaired numerous times since its construction in 1930 due to 6-8 feet of channel bed incision or degradation.

Under existing conditions, the natural habitats and geomorphic processes of the Napa River are highly confined. In most years, all of the sediment transport and geomorphic process work occurs in a limited area of the streambed and channel banks. Only rarely does flow exceed the banks and reach the valley floor. Once large floods have passed, the valley floor areas are reclaimed to agricultural or urban uses. Examination of historical aerial photographs for this study and by Stillwater Sciences (2002) found substantial reduction in overbank flood channels and the width of the riparian corridor and flood plain. **Figure 8** shows a reach upstream of St. Helena in 1940, where multiple flood channels were lined with large trees. These overflow channels may have been the main channel at some time, however it is clear that the riparian ecosystem of the Napa River extended well beyond its flood channel and that considerable reclamation work has narrowed it to its current extent. The same historic encroachment appears in the project reach where prominent overflow channels occur within 1,000 feet of the present river bank. Recent aerial photographs (**Figure 3**) show one channel extending into the floodwall on the west side of the Vineyard Valley Mobile Home Park. The narrowing of the channel by filling would partially explain the 6 to 8 feet of historical channel degradation documented in the Napa River [**Figure 4** and Stillwater Sciences (2002)].

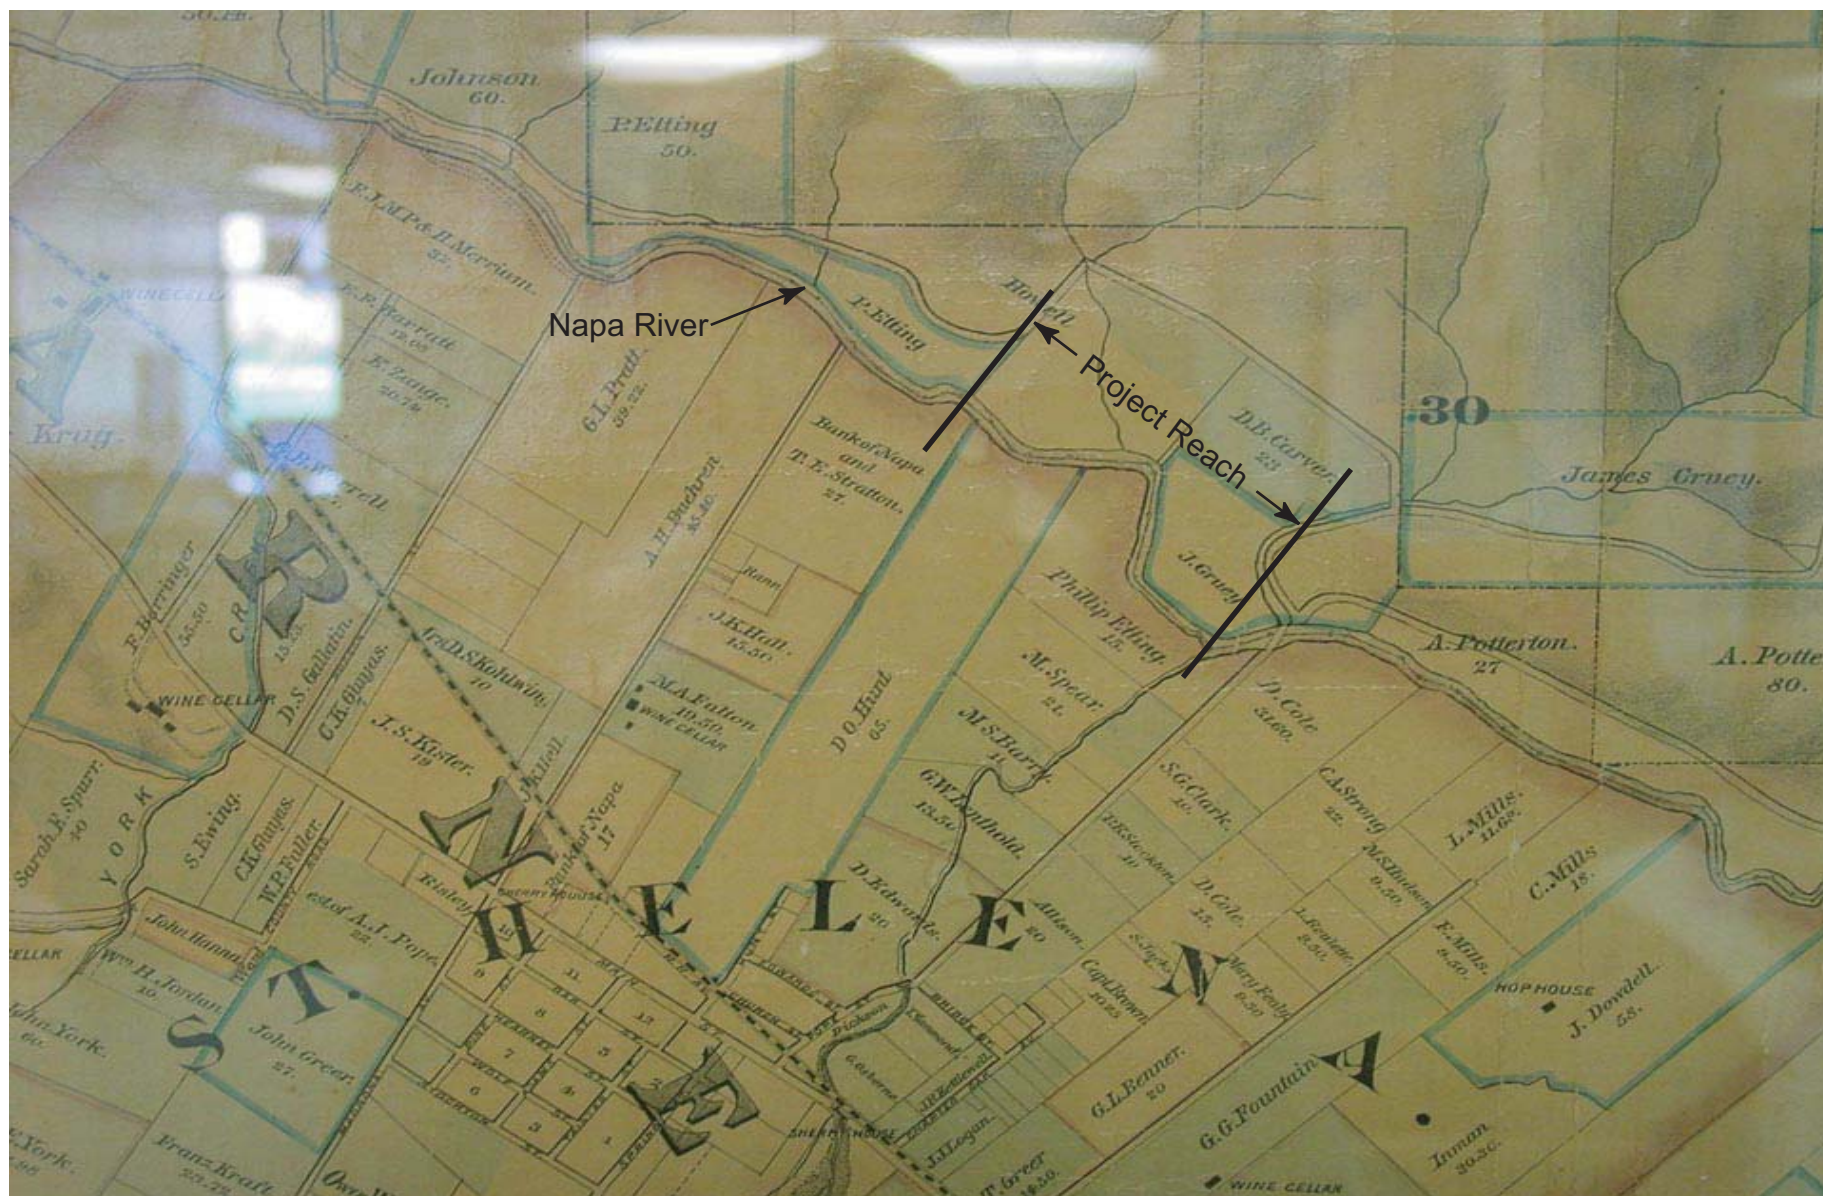
Figure 5: 1850's local plot map showing the Napa River with essentially the same location as today.
 Source: City of St. Helena.

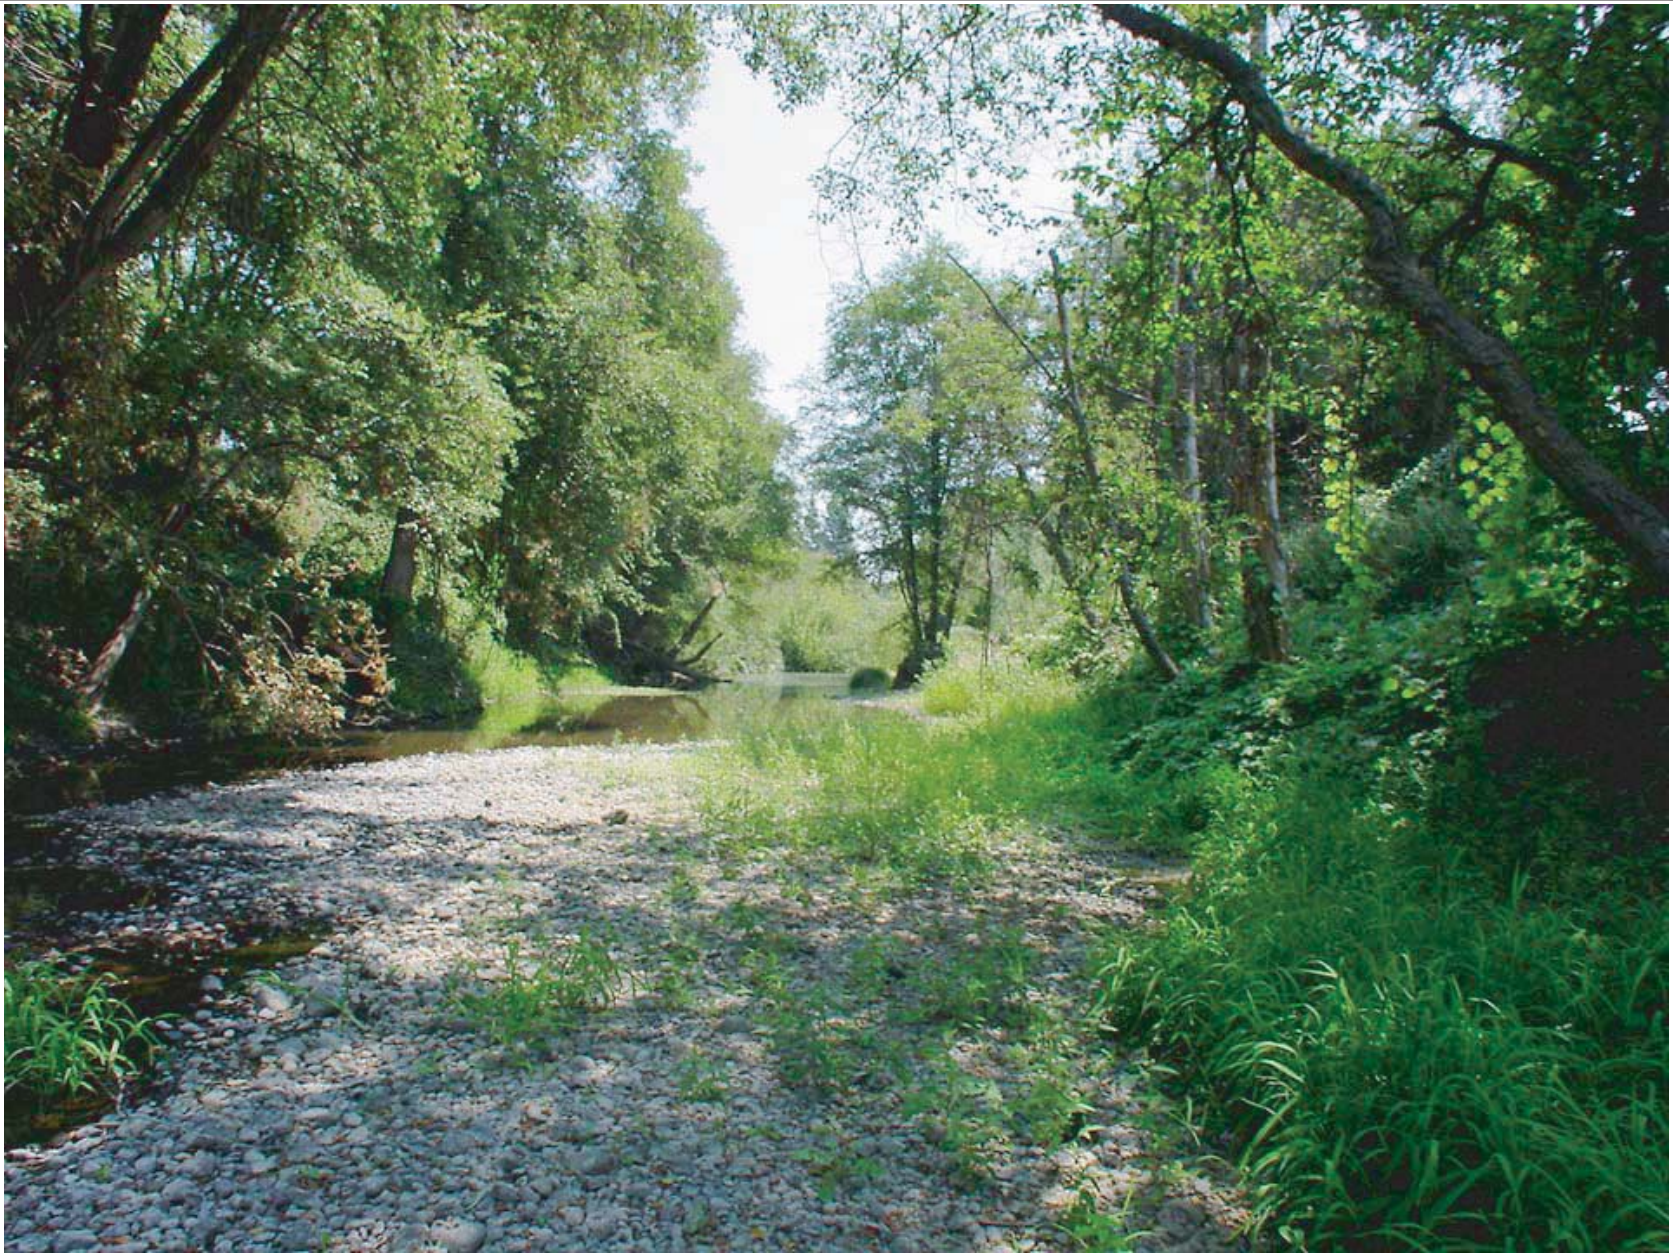
Figure 6: Napa River near upstream end of project boundary. Note clear channel bed with overstory shading provided by canopy. All oak trees in this area to be preserved with project.

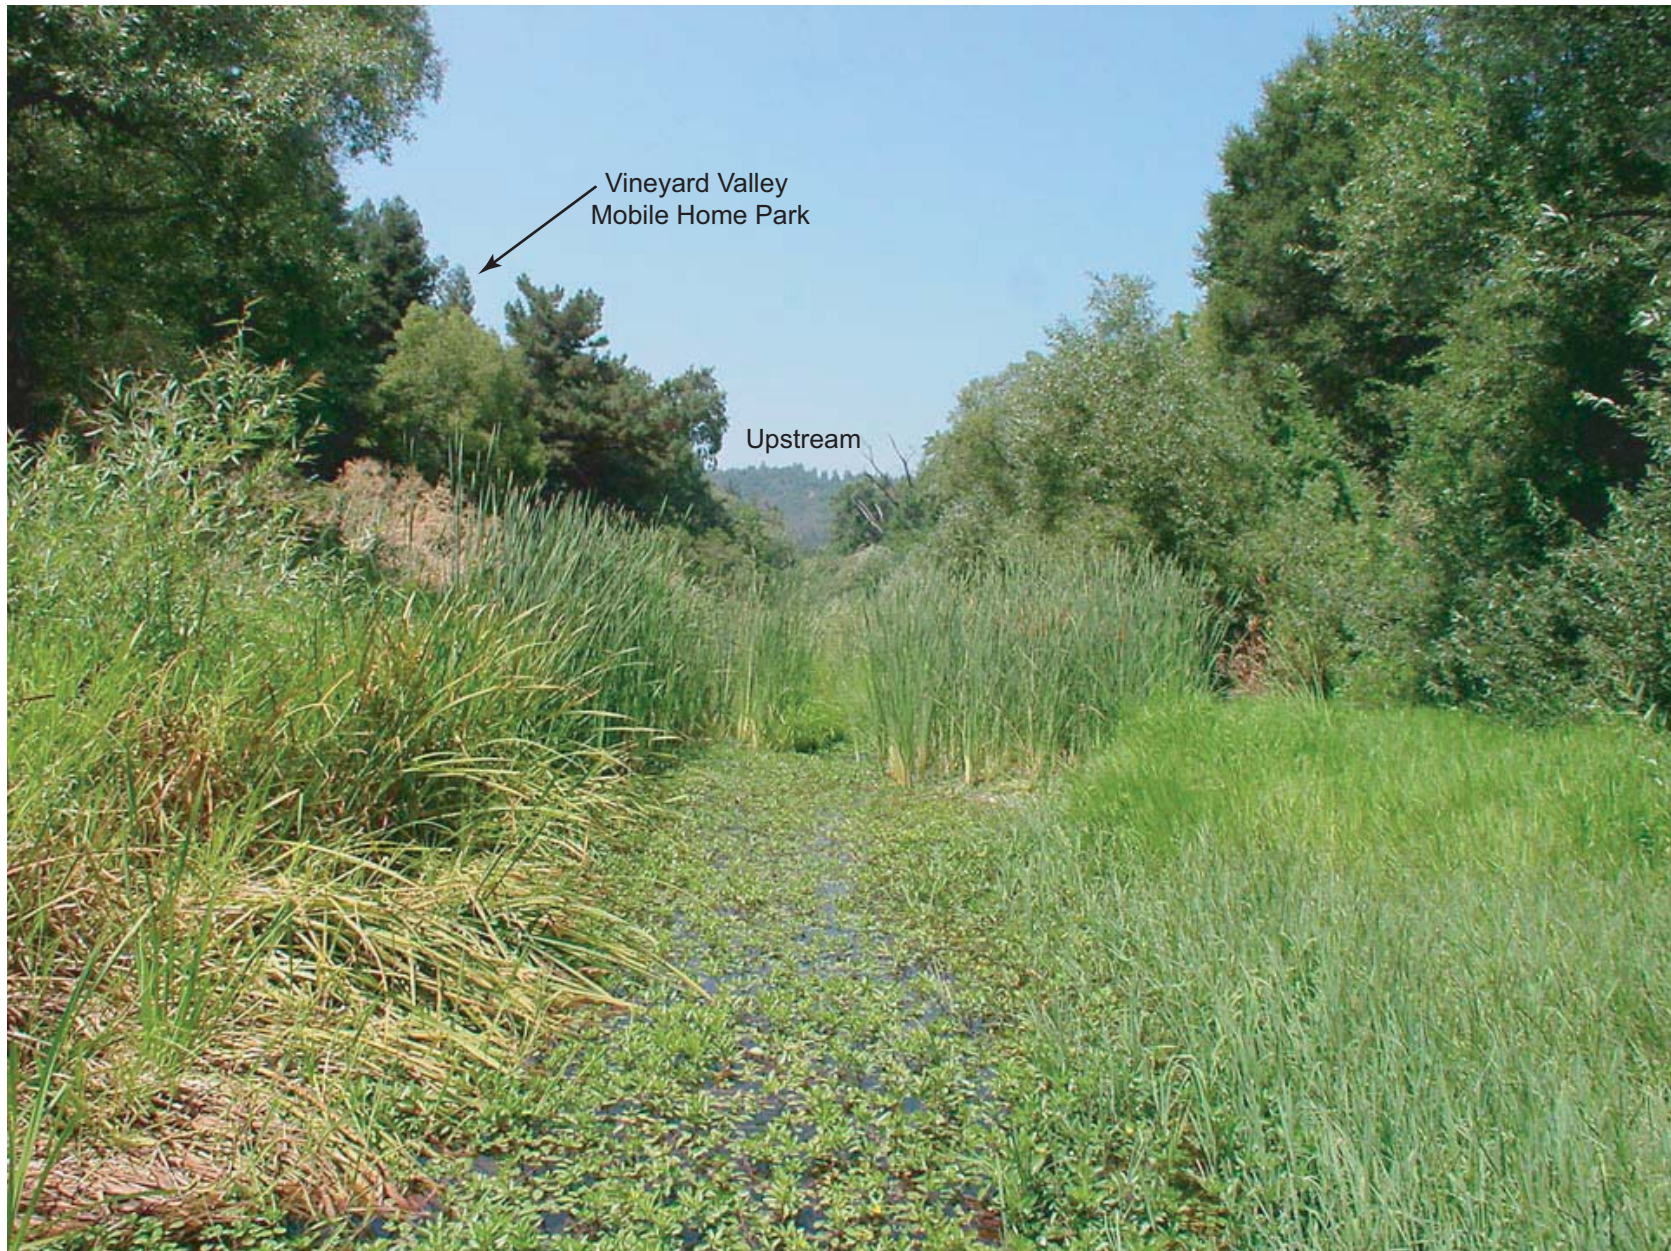
Figure 7: Napa River looking upstream near Vineyard Valley Mobile Home Park. This reach is open to sunlight which promotes early successional growth of willow-sedges and cattails

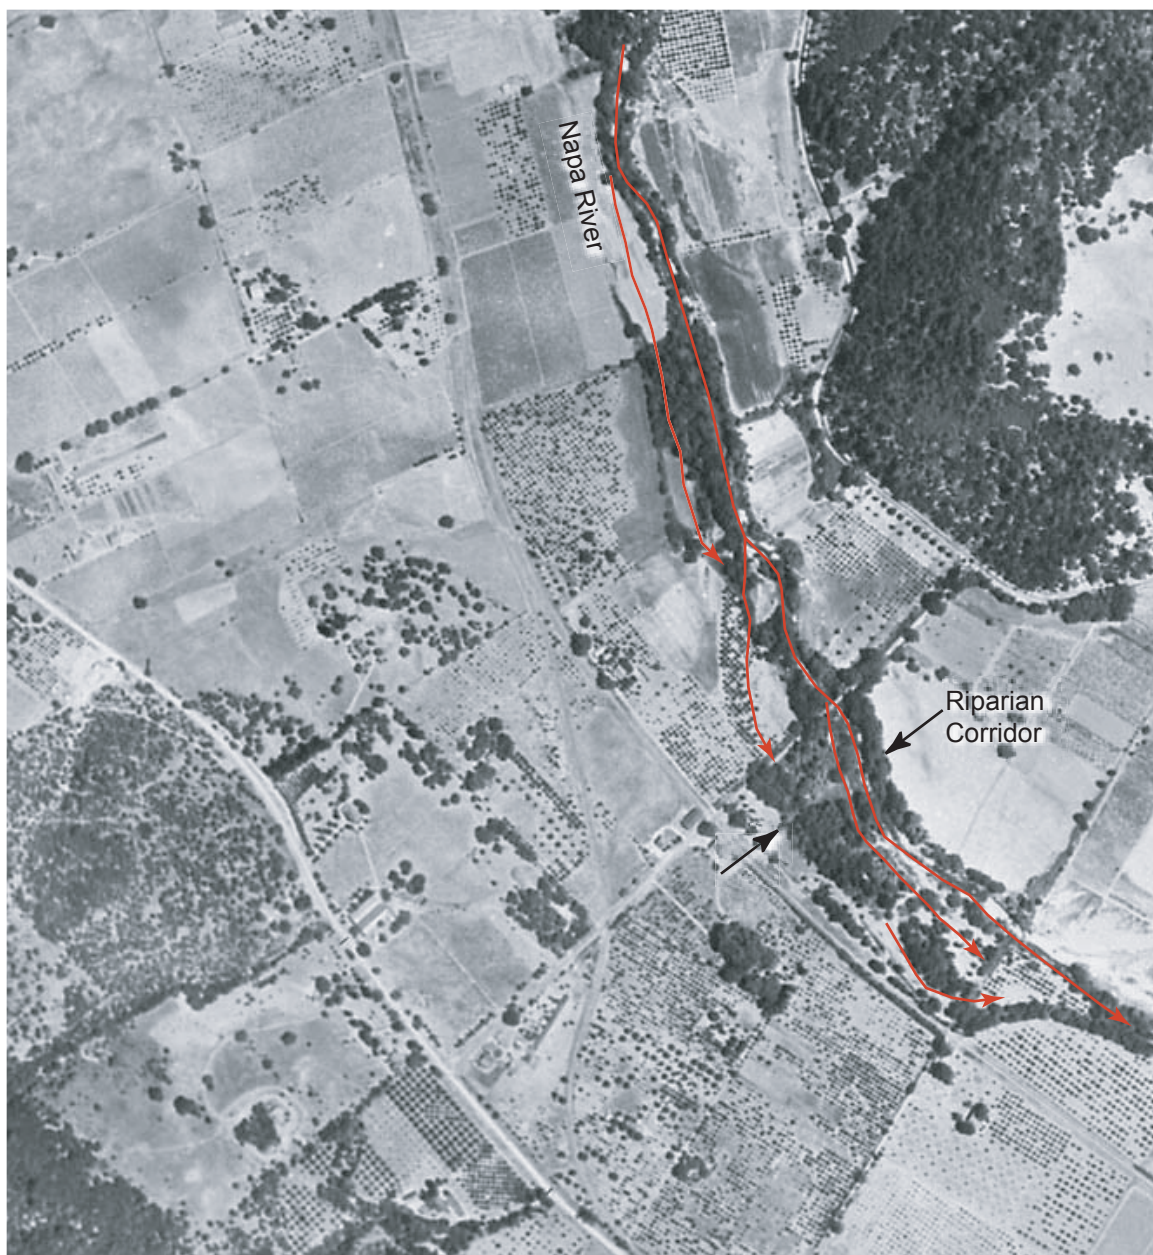
Figure 8: Napa River upstream of St. Helena showing wide riparian corridor with multiple flood channels in July 1940.
(scale is approximately 1" = 750')

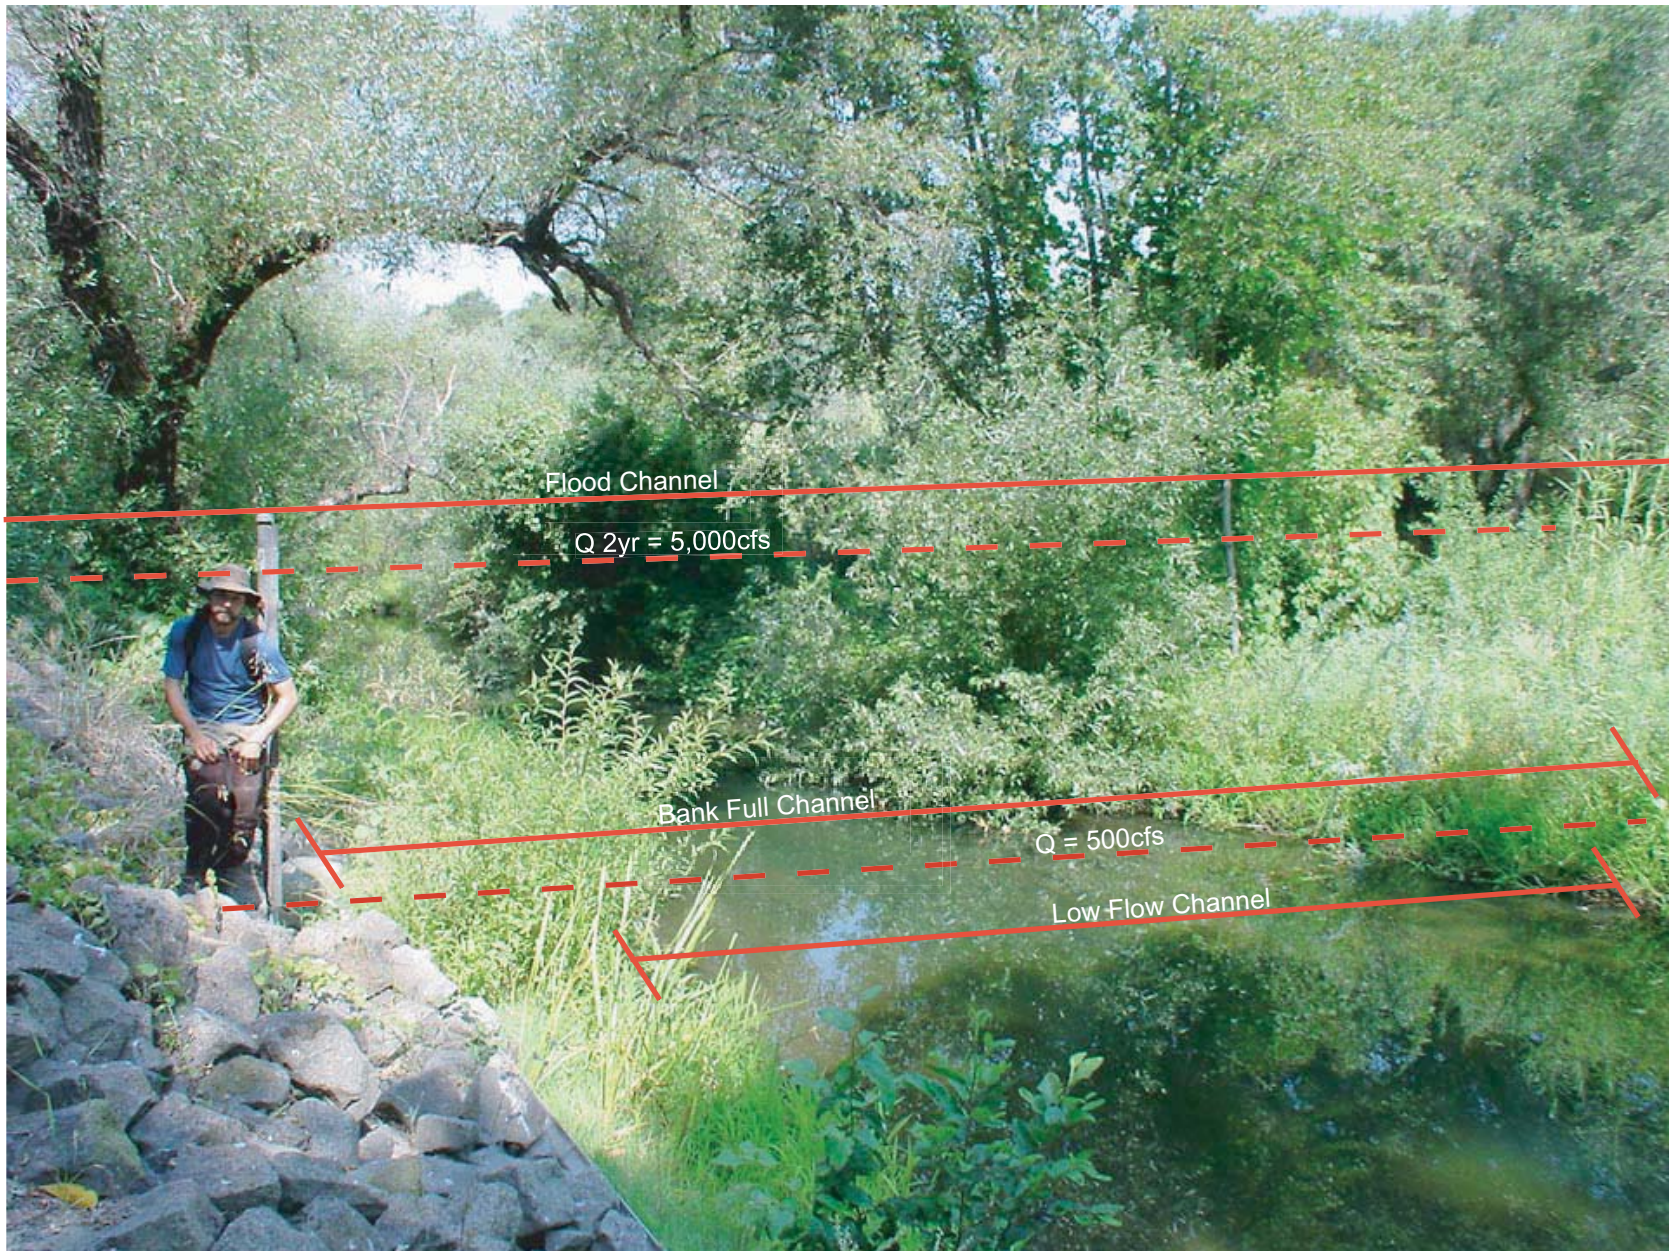
Figure 9: Napa River near St. Helena USGS gaging station showing various stage channels and corresponding discharge values.

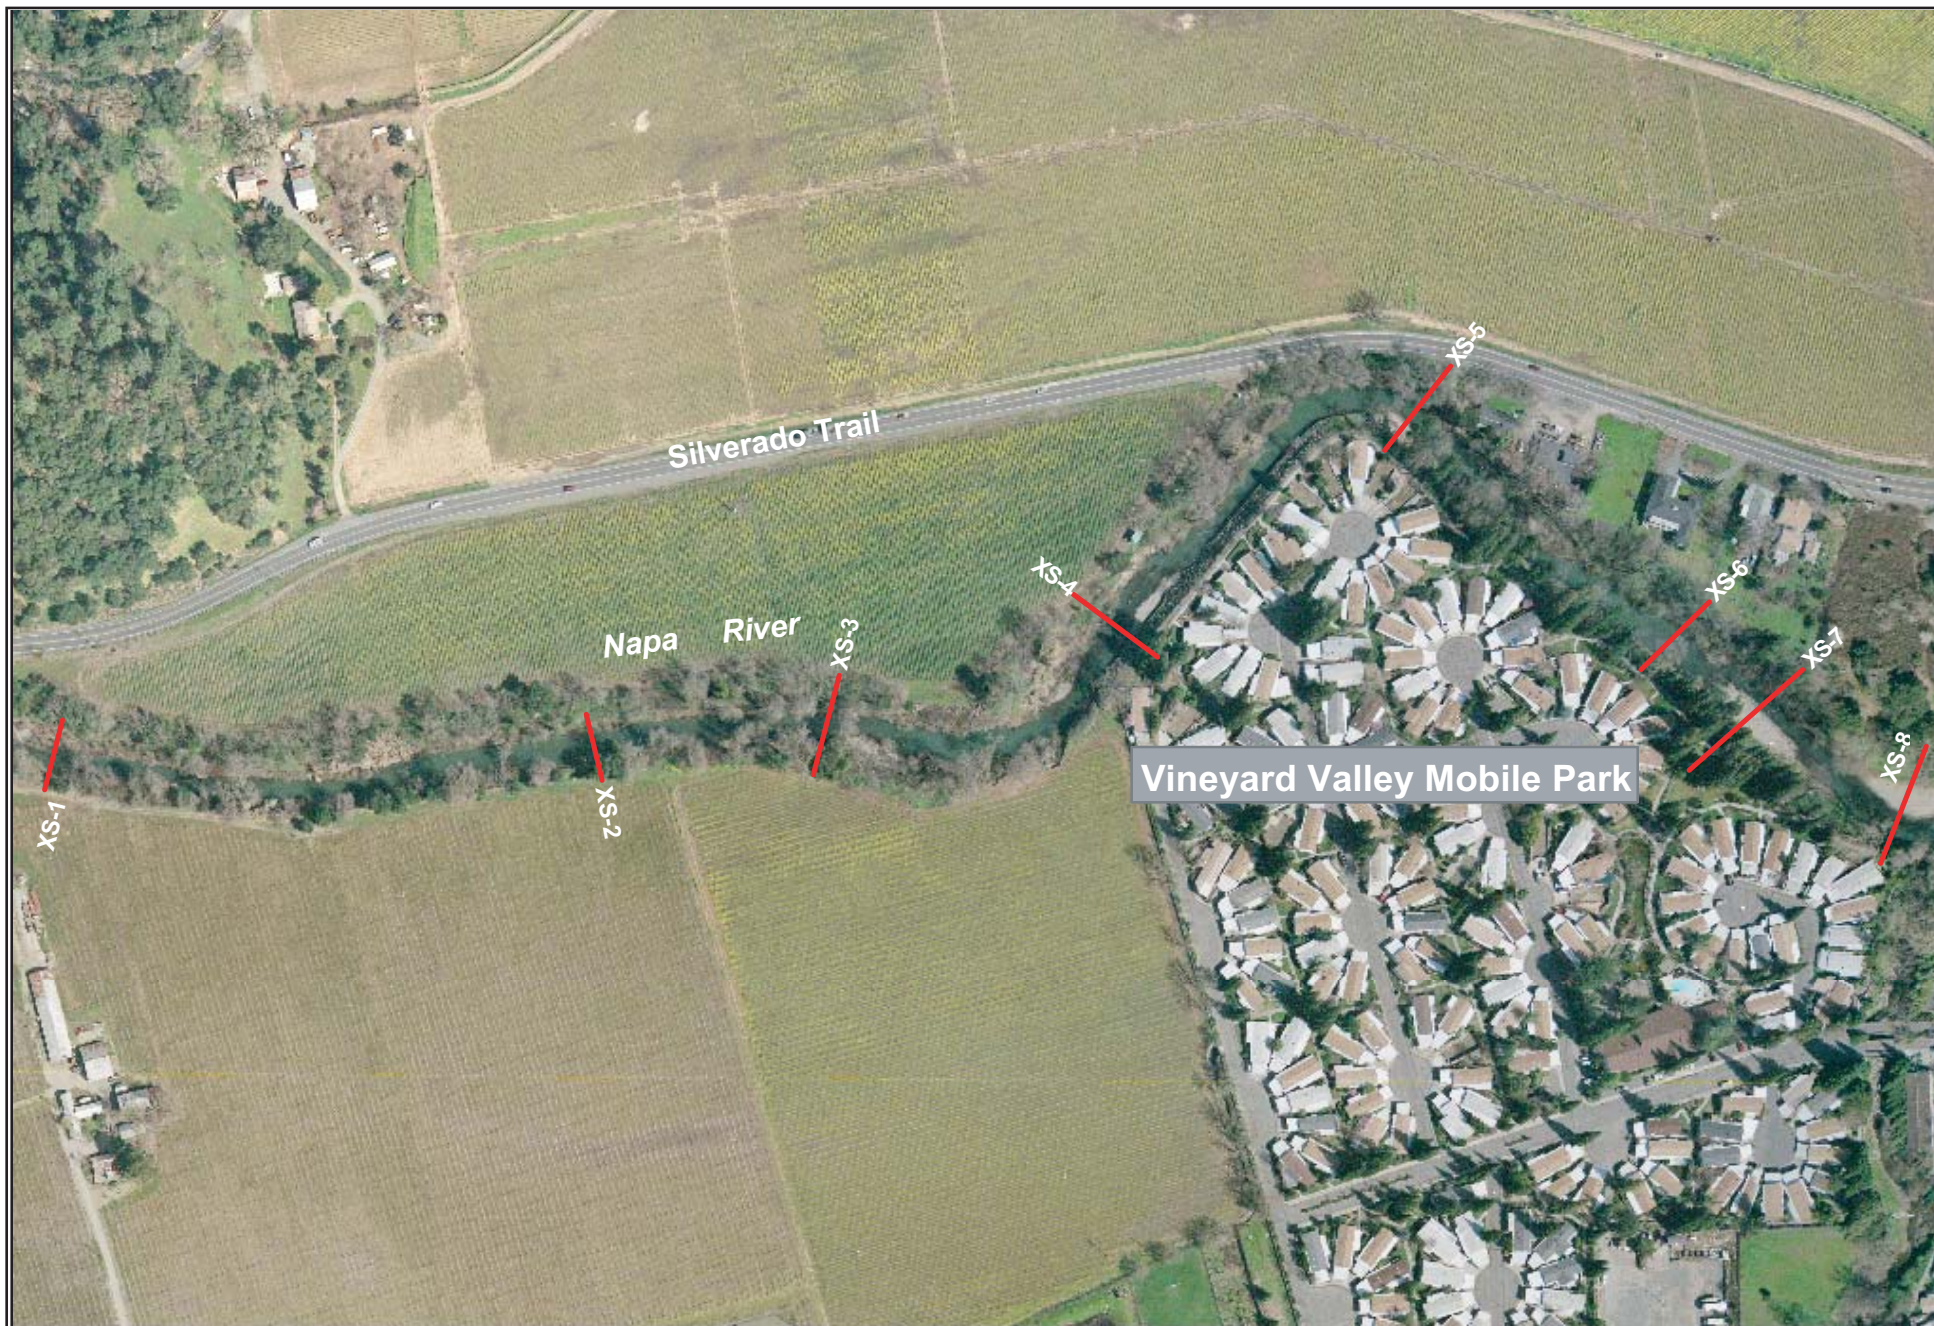
Figure 10: SH&G measured cross sections (XS) 1 - 8
 in project reach.

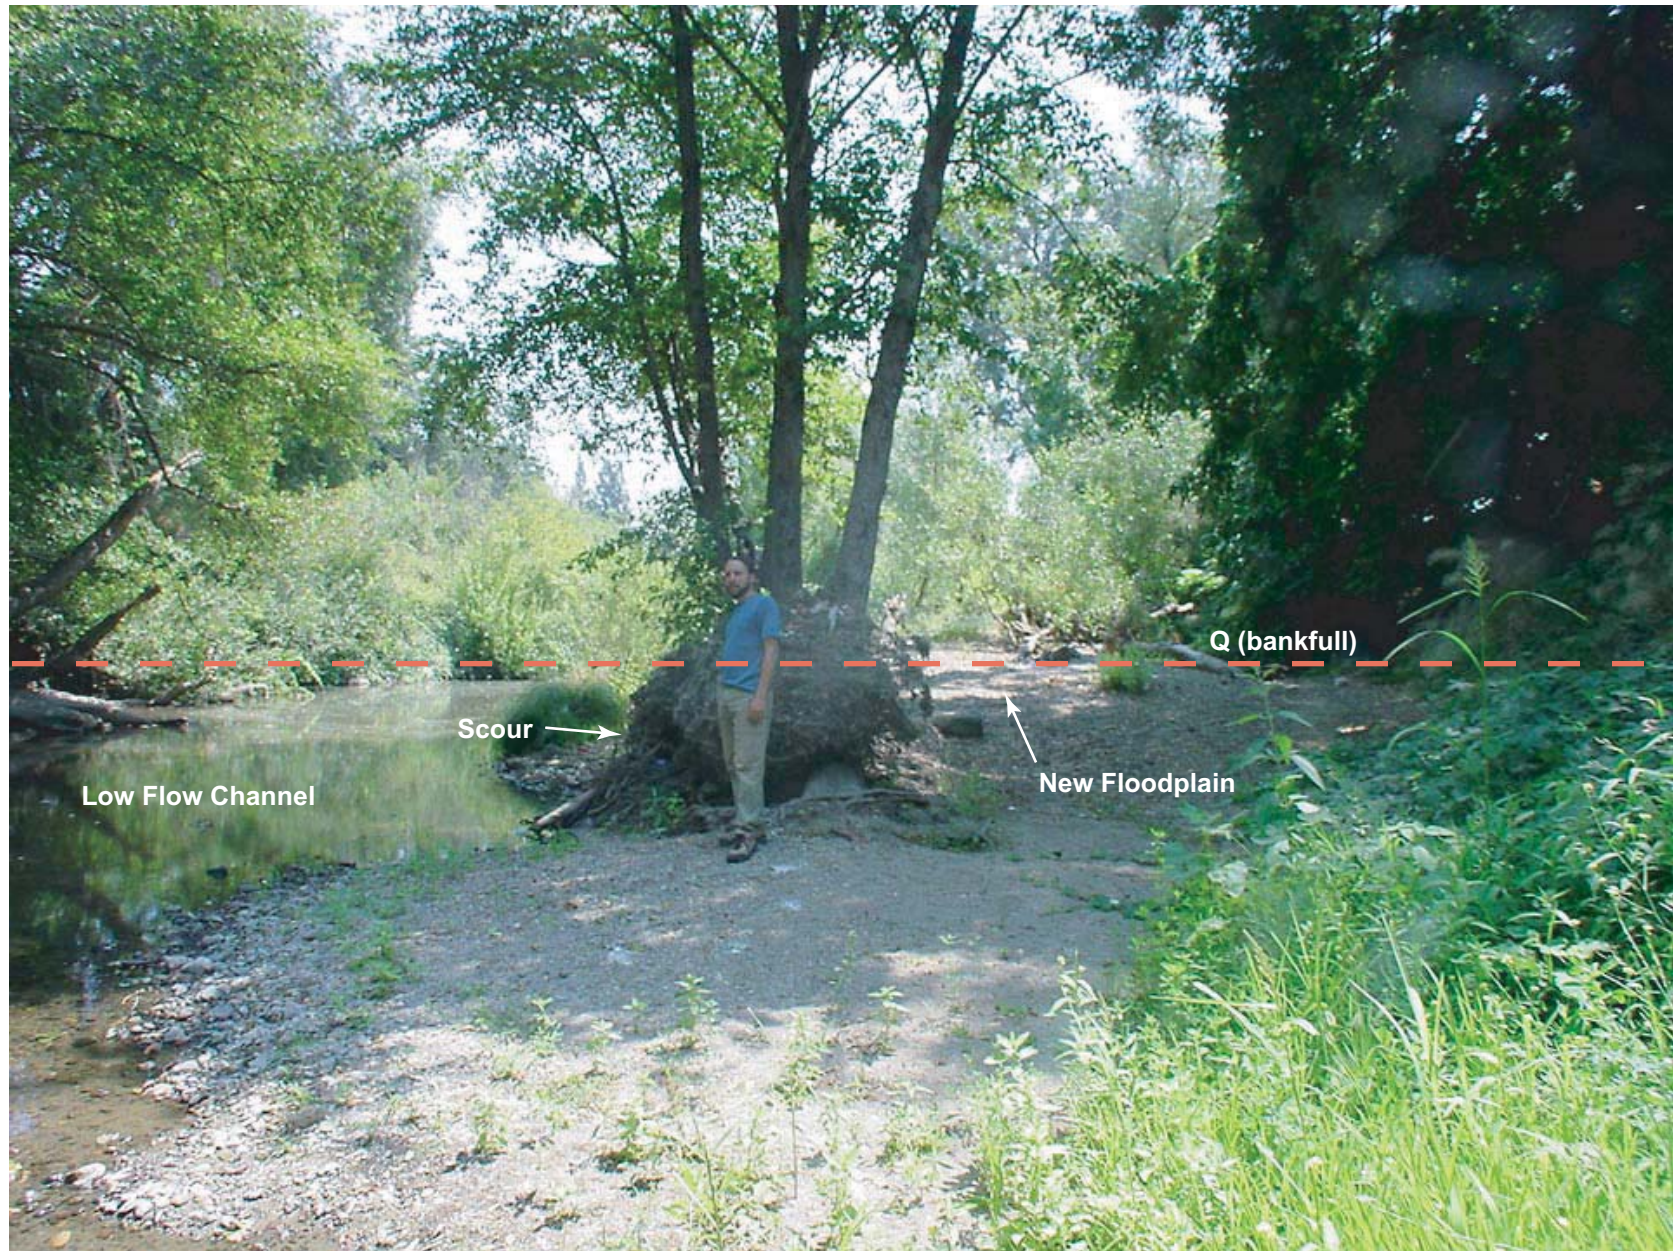
Figure 12: Napa River near St. Helena near SH&G cross section #2. Undercut group of alders are situated at bankfull flow with a depth of about 4.5 feet and width of 55 feet. Note scour below bankfull flow.
